**SITE RECONNAISSANCE TRIP REPORT
FOR THE
FEDERATED METALS DIVISION
PITTSBURGH, ALLEGHENY COUNTY, PENNSYLVANIA**

Project Remedial Action Contract No. 68-S7-3002
Work Assignment No. 048-PAPA-03ZZ
No. I4185.47502.0903

September 12, 2005

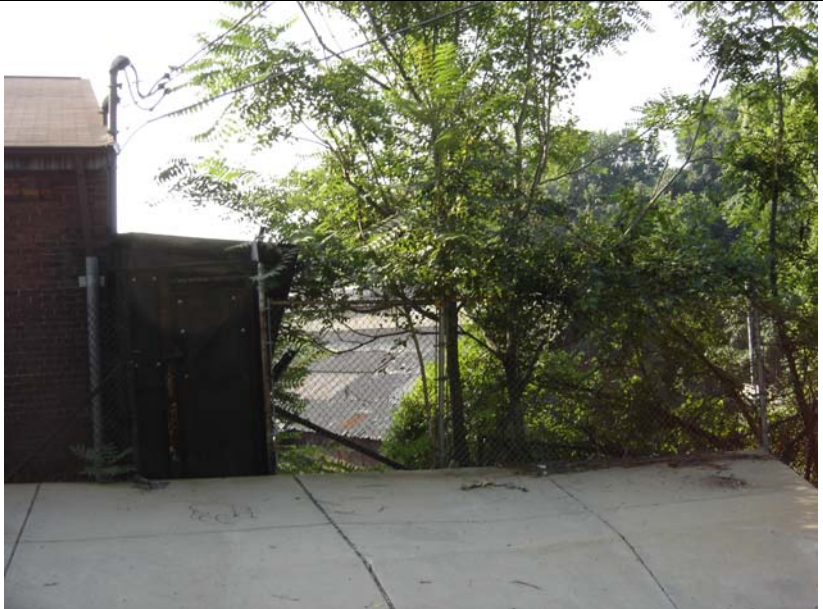
Photo 1:

Roof of building that appears to be vacated; site consists of three buildings and this is one of them; photo taken from Gross Street

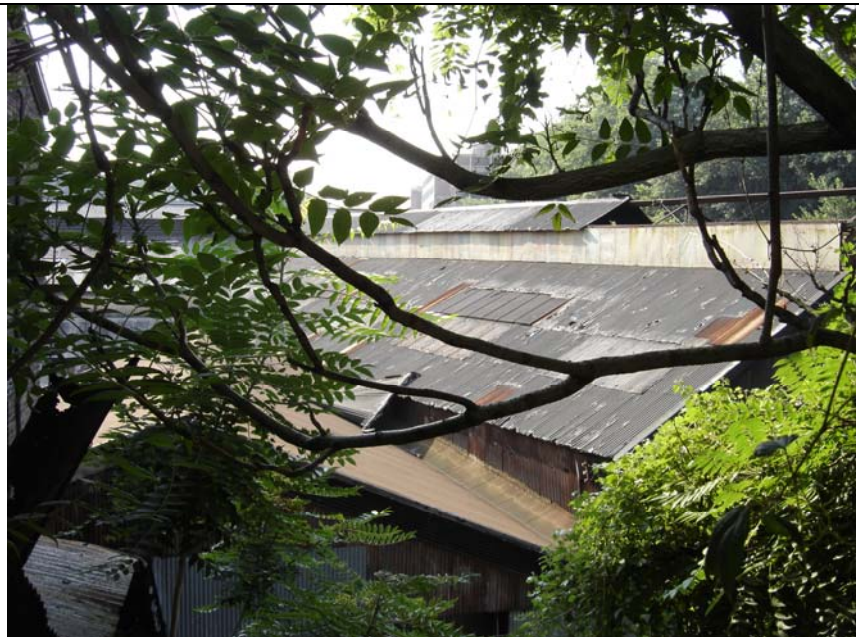
Photo 2:

Roof of building that appears to be vacated; site is fenced; photo taken from Gross Street

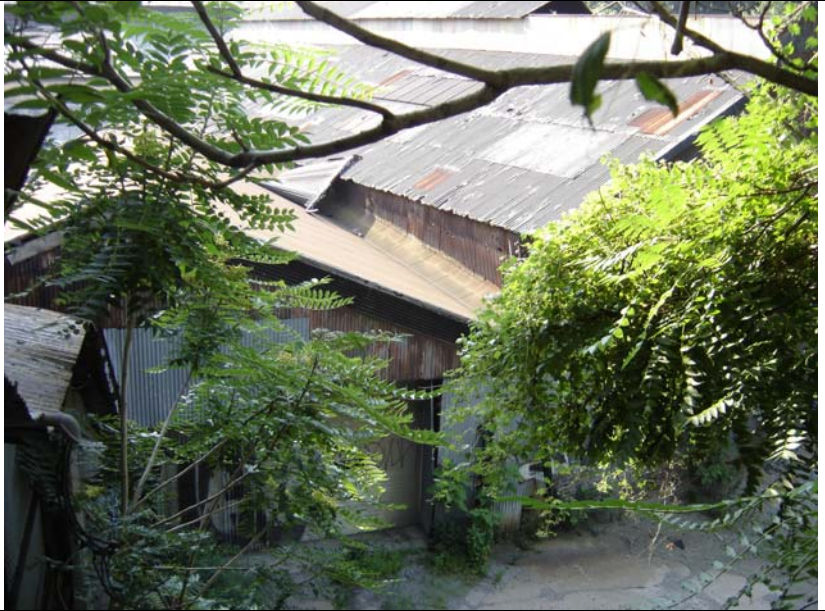
Photo 3:

Courtyard of building
that appears to be
vacated; photo taken
from Gross Street

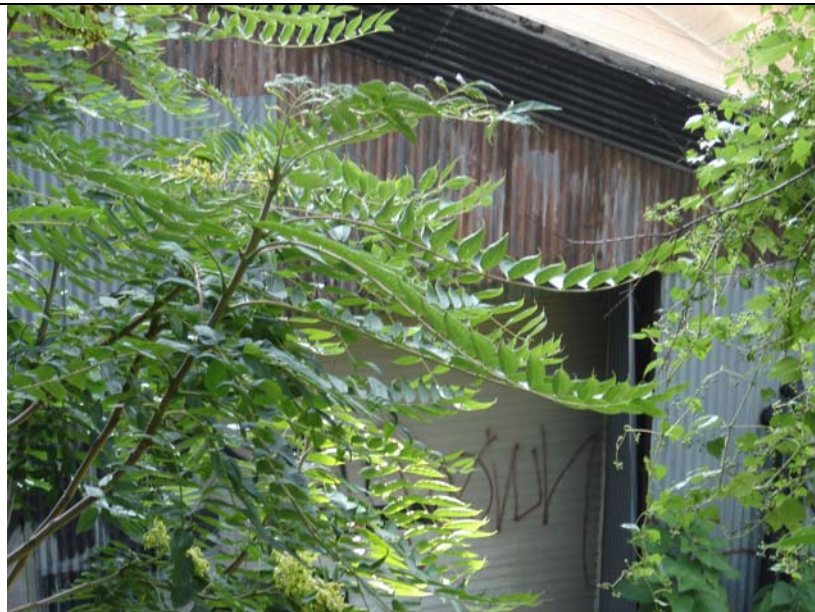
Photo 4:

- Graffiti was identified on the side and roof of the industrial looking building with metal walls and a metal roof.
- Residential properties are located within 200 feet; therefore, additional work is warranted at this location to determine if the smelting activities that reportedly occurred at this location contaminated nearby residential areas.

Courtyard of building
that appears to be
vacated; photo taken
from Gross Street;
graffiti on wall

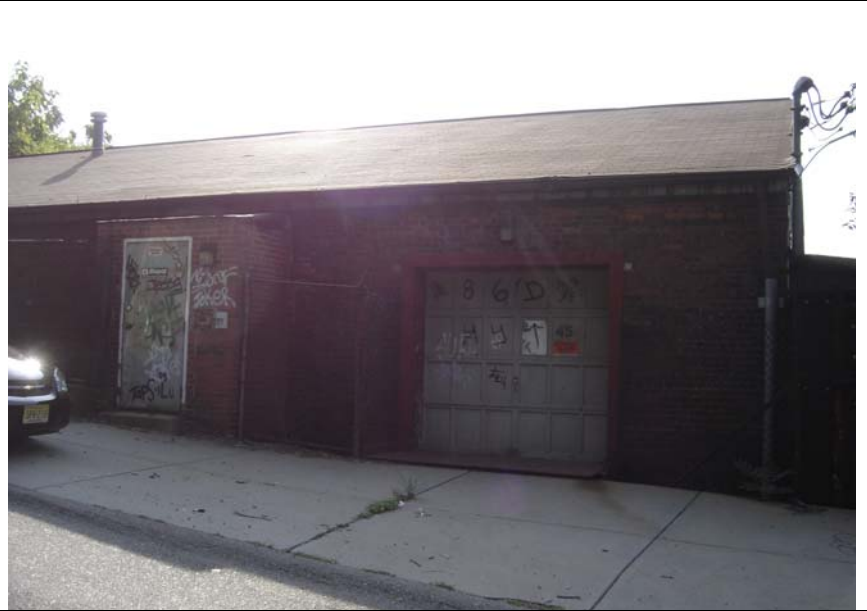
Photo 5:

Small building on Gross Street which appears to be part of site; north of building that appears to be vacated; south of Hallcraft office building

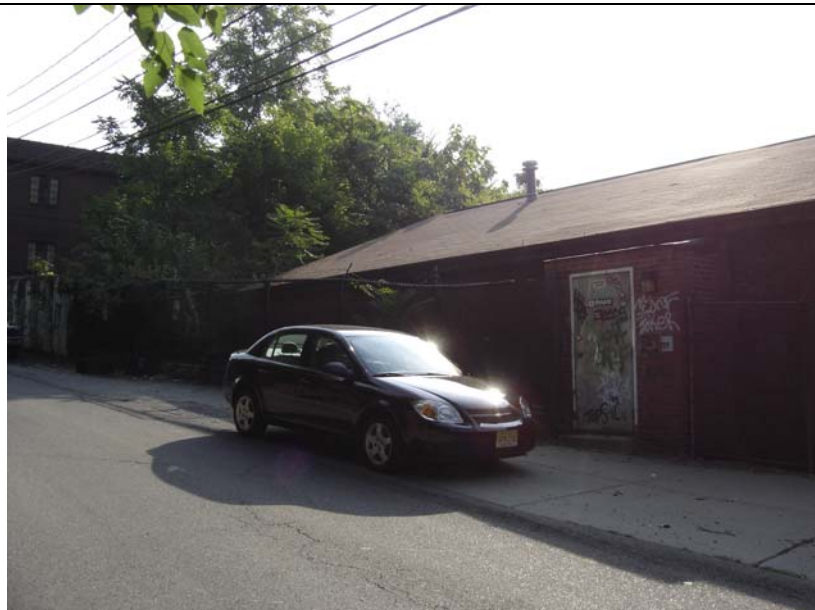
Photo 6:

Small building on Gross Street which appears to be part of site; north of building that appears to be vacated; south of Hallcraft office building

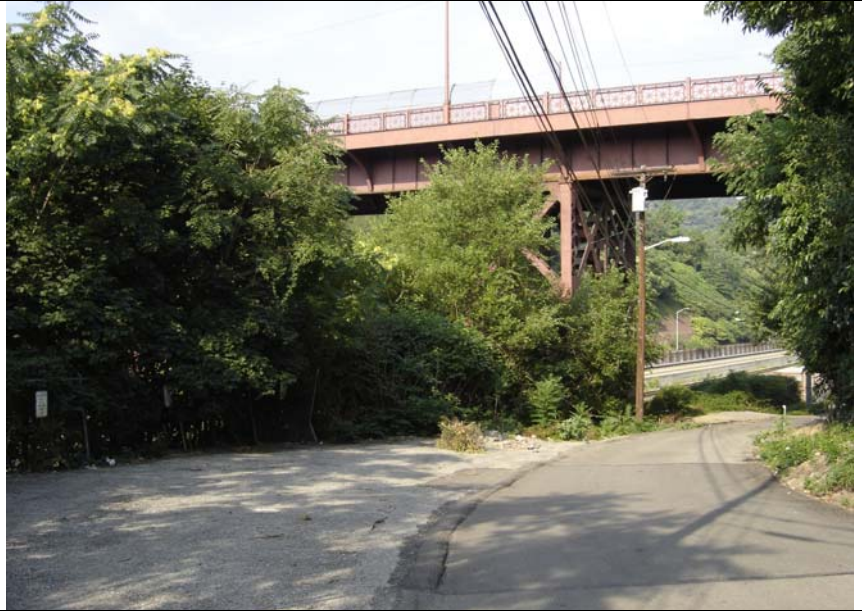
Photo 7:

Bridge to southwest of
the site; train tracks and
bus way runs east and
west, south of site

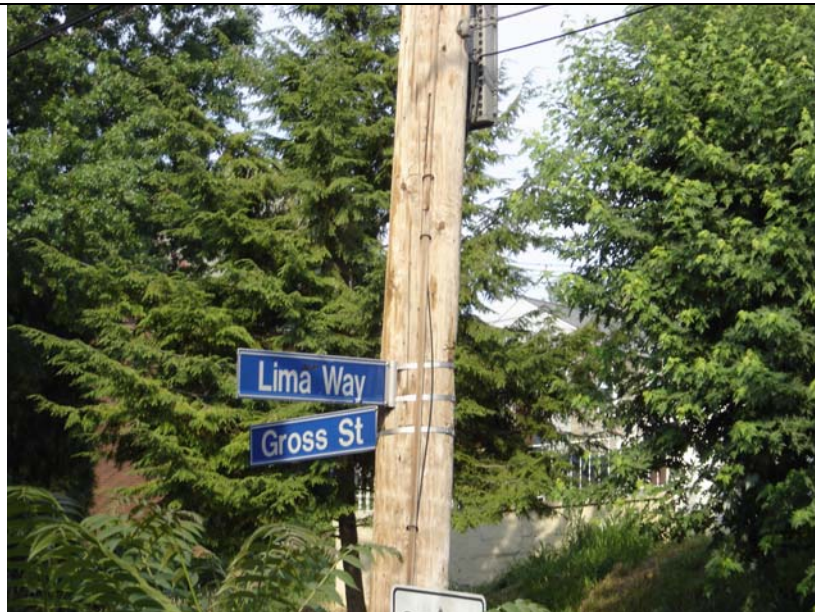
Photo 8:

Street sign at
intersection of site
location

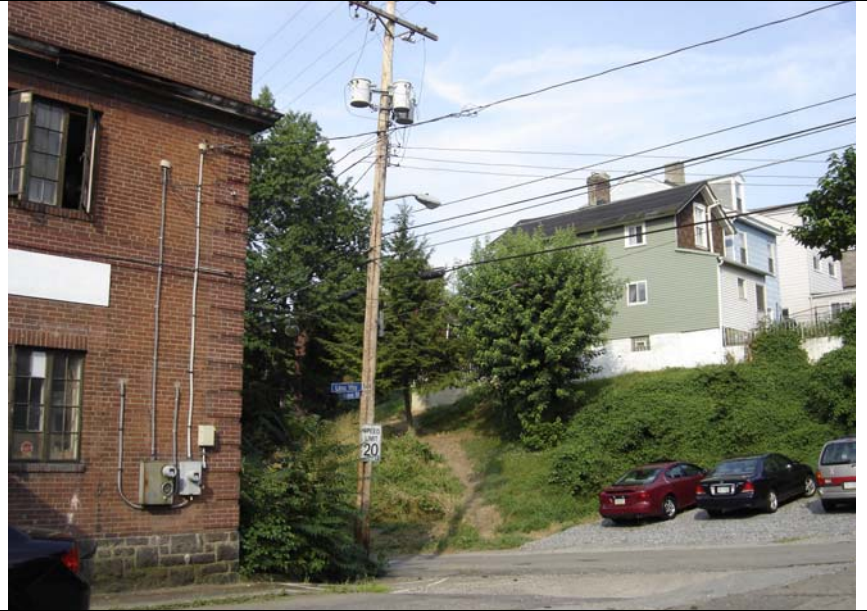
Photo 9:

Building at 615 Gross Street; formerly part of the site; presently used as Hallcraft offices

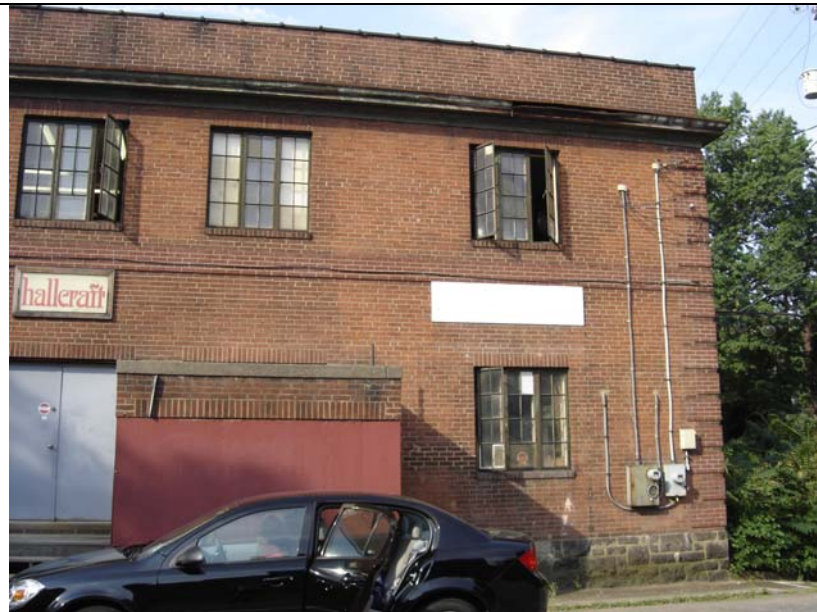
Photo 10:

Building at 615 Gross Street; formerly part of the site; presently used as Hallcraft offices

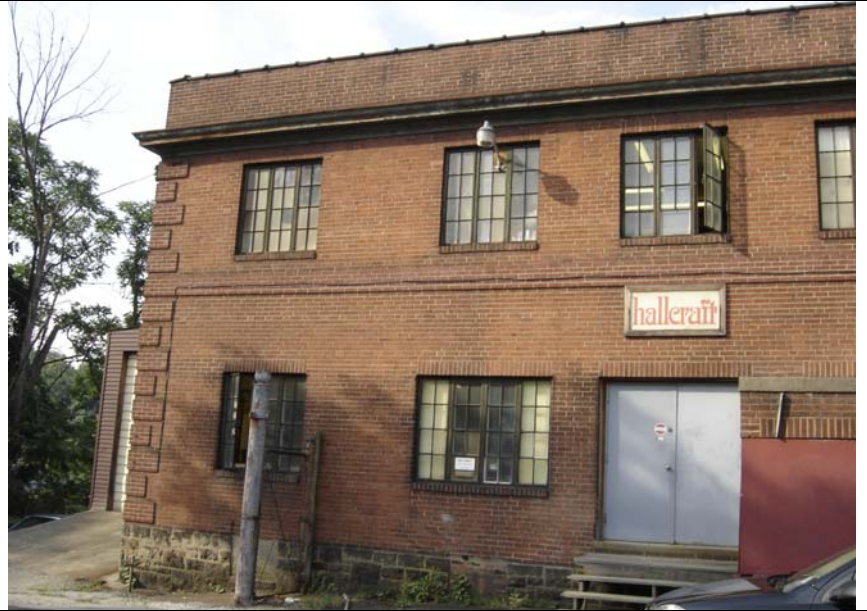
Photo 11:

Building at 615 Gross Street; formerly part of the site; presently used as Hallcraft offices

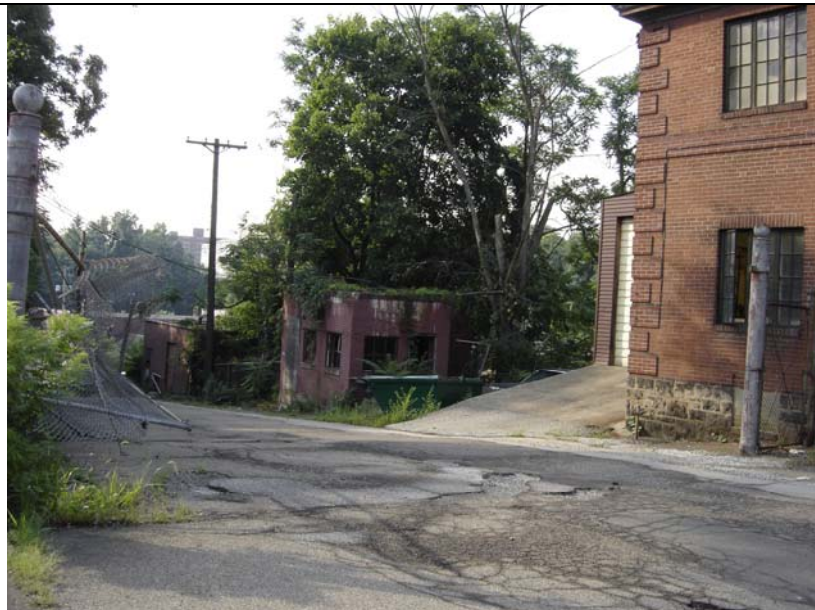
Photo 12:

Lima Way runs on the north side of 615 Gross Way down to other site buildings

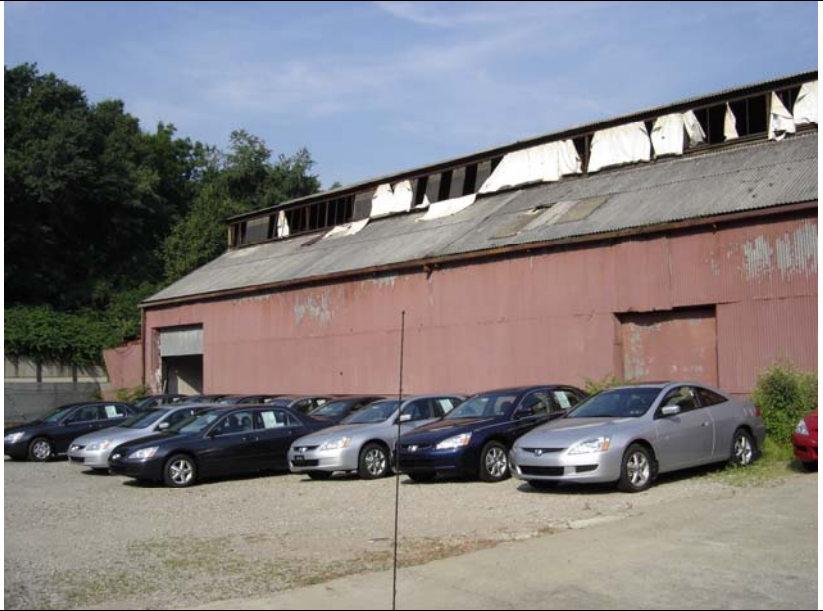
Photo 13:

East side of building that appears to be vacated but may be used for storage

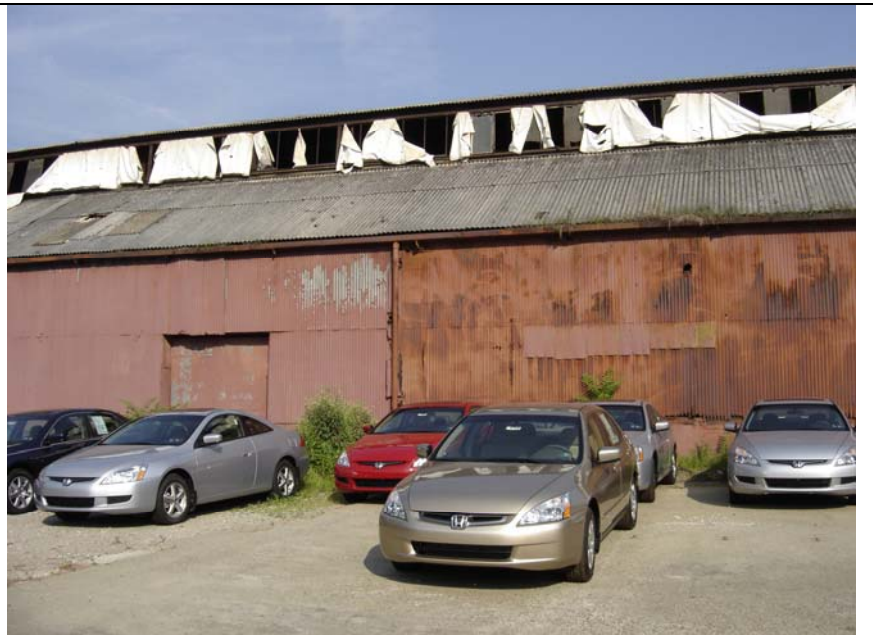
Photo 14:

East side of building that appears to be vacated but may be used for storage

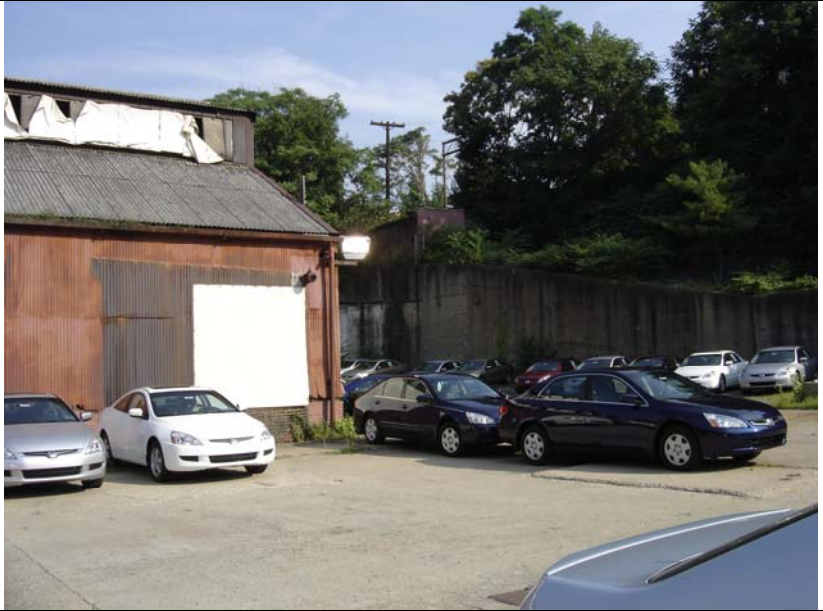
Photo 15:

Northeast corner of building that appears to be vacant but may be used for storage; notice Lima way in background

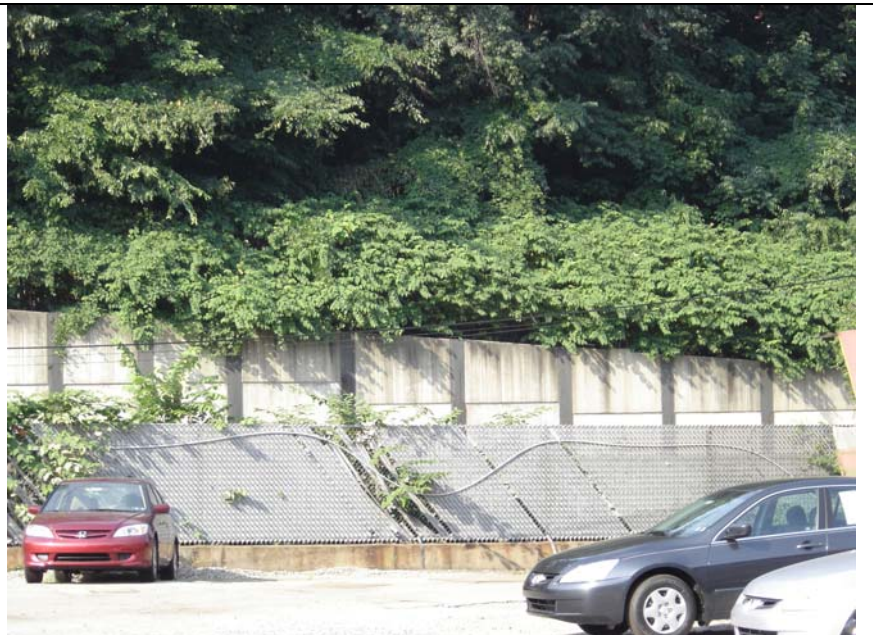
Photo 16:

Wall and fence on south side of lower section of site

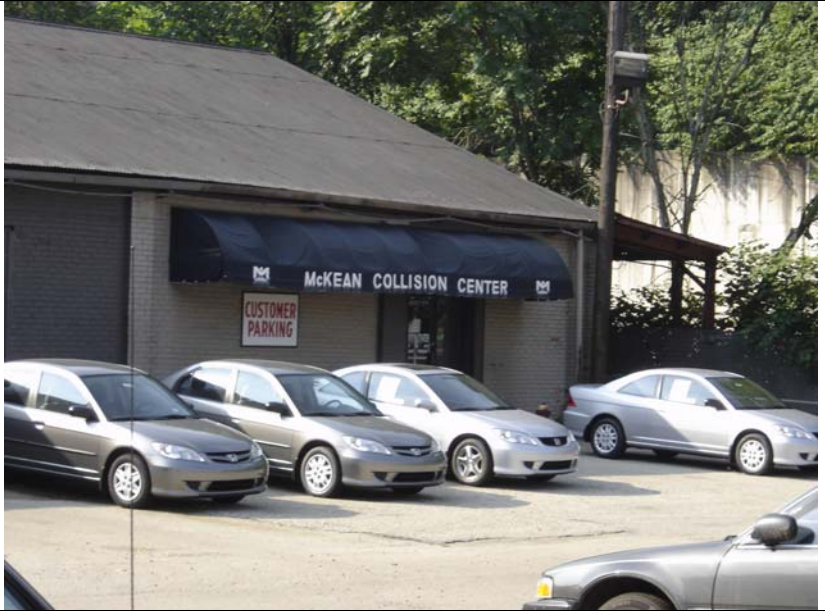
Photo 17:
McKean Collision
Center; East of building
that appears to be
vacated

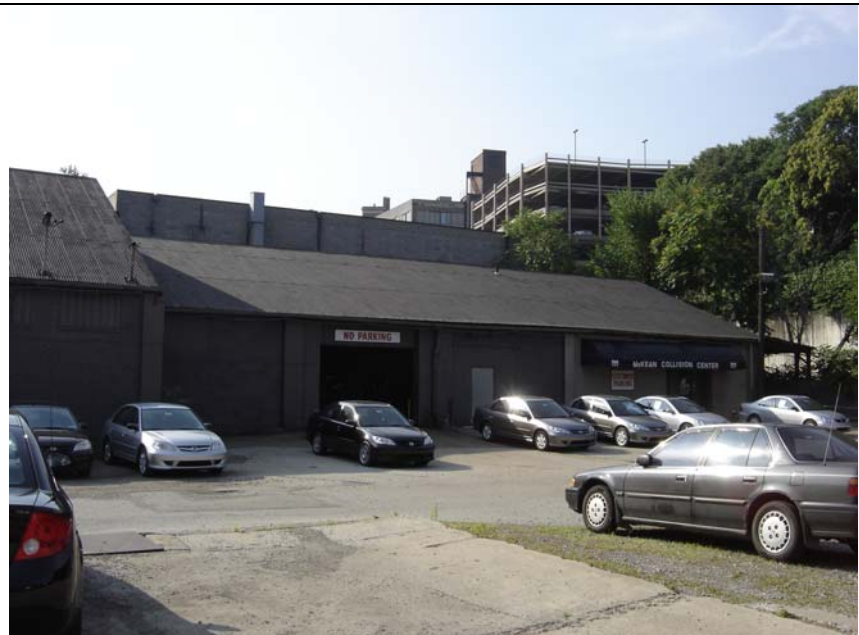
Photo 18:
McKean Collision
Center; East of building
that appears to be
vacated

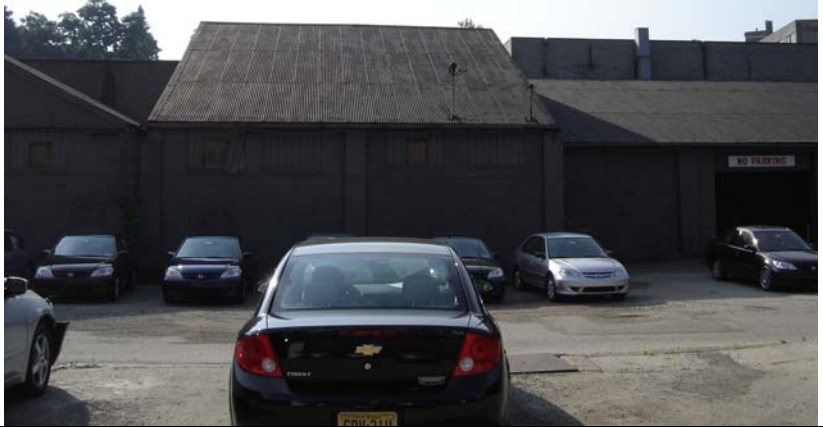
Photo 19:

McKean Collision
Center; East of building
that appears to be
vacated

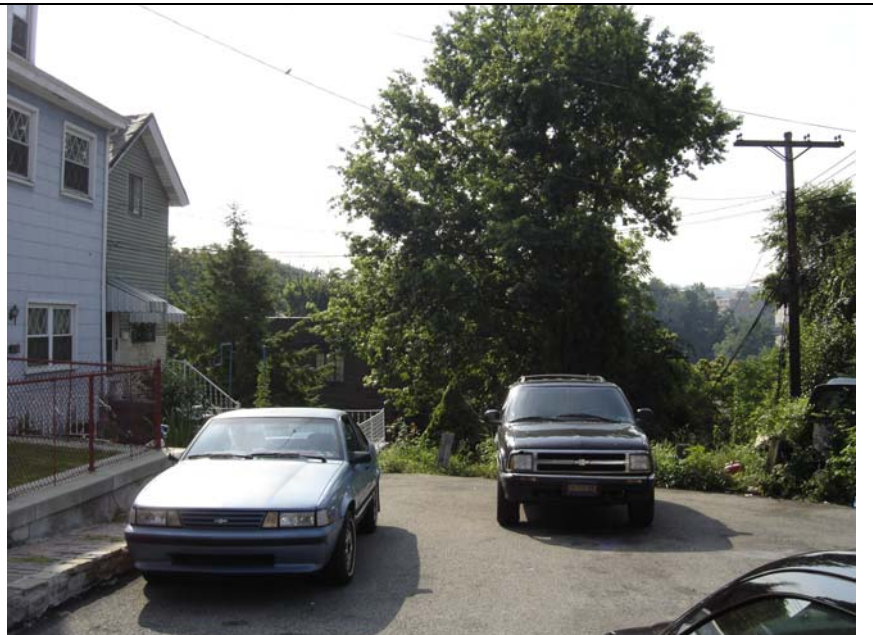
Photo 20:

Residences on Yew
Street; up a hill and
across the street from
615 Gross Street; notice
615 Gross Street
building in the
background

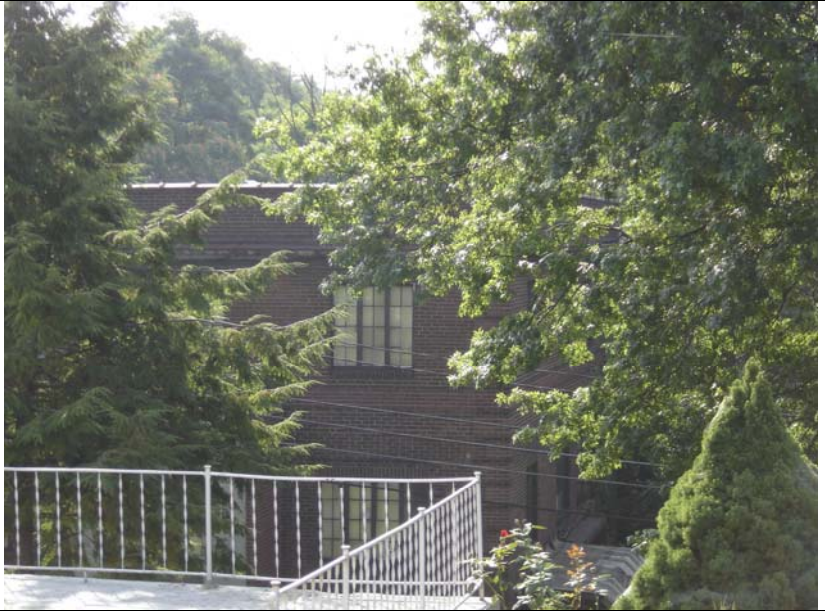
Photo 21:

Perspective from
residence on Yew Street
toward 615 Gross Street

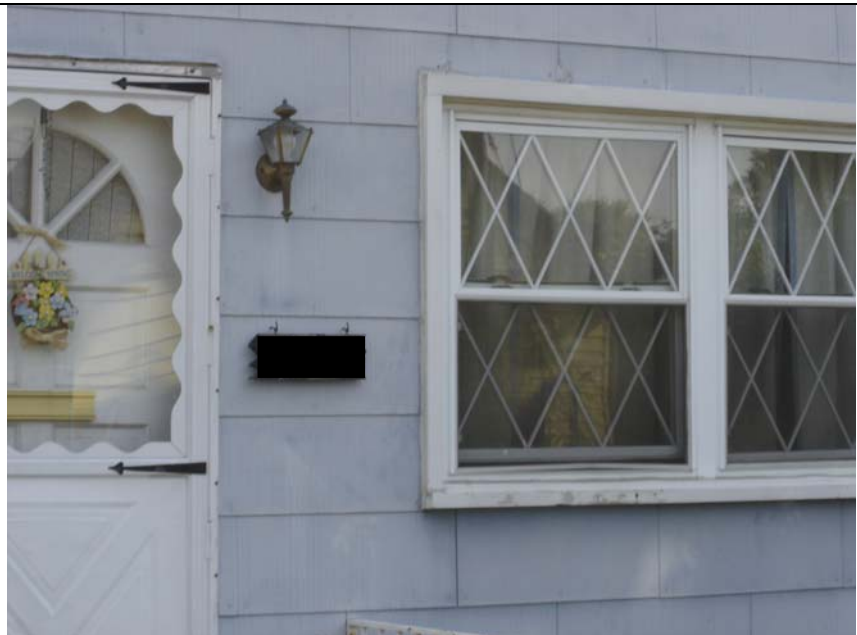
Photo 22:

Residence on Yew
Street; up the hill and
across the street from
615 Gross Street
